SANDRINGHAM ROAD
CHEADLE HULME
STOCKPORT

GEO-ENVIRONMENTAL INVESTIGATION AND ASSESSMENT
FOR
STOCKPORT HOMES

Report Title:	Sandringham Road, Cheadle Hulme, Stockport. Geo-environmental Investigation and Assessment.
Report Reference:	5062/G/02
Client:	Stockport Homes
Issue Date:	8 th February 2012
Drafted By:	P G Davies  
Reviewed By:	
Authorised By:	P G Davies

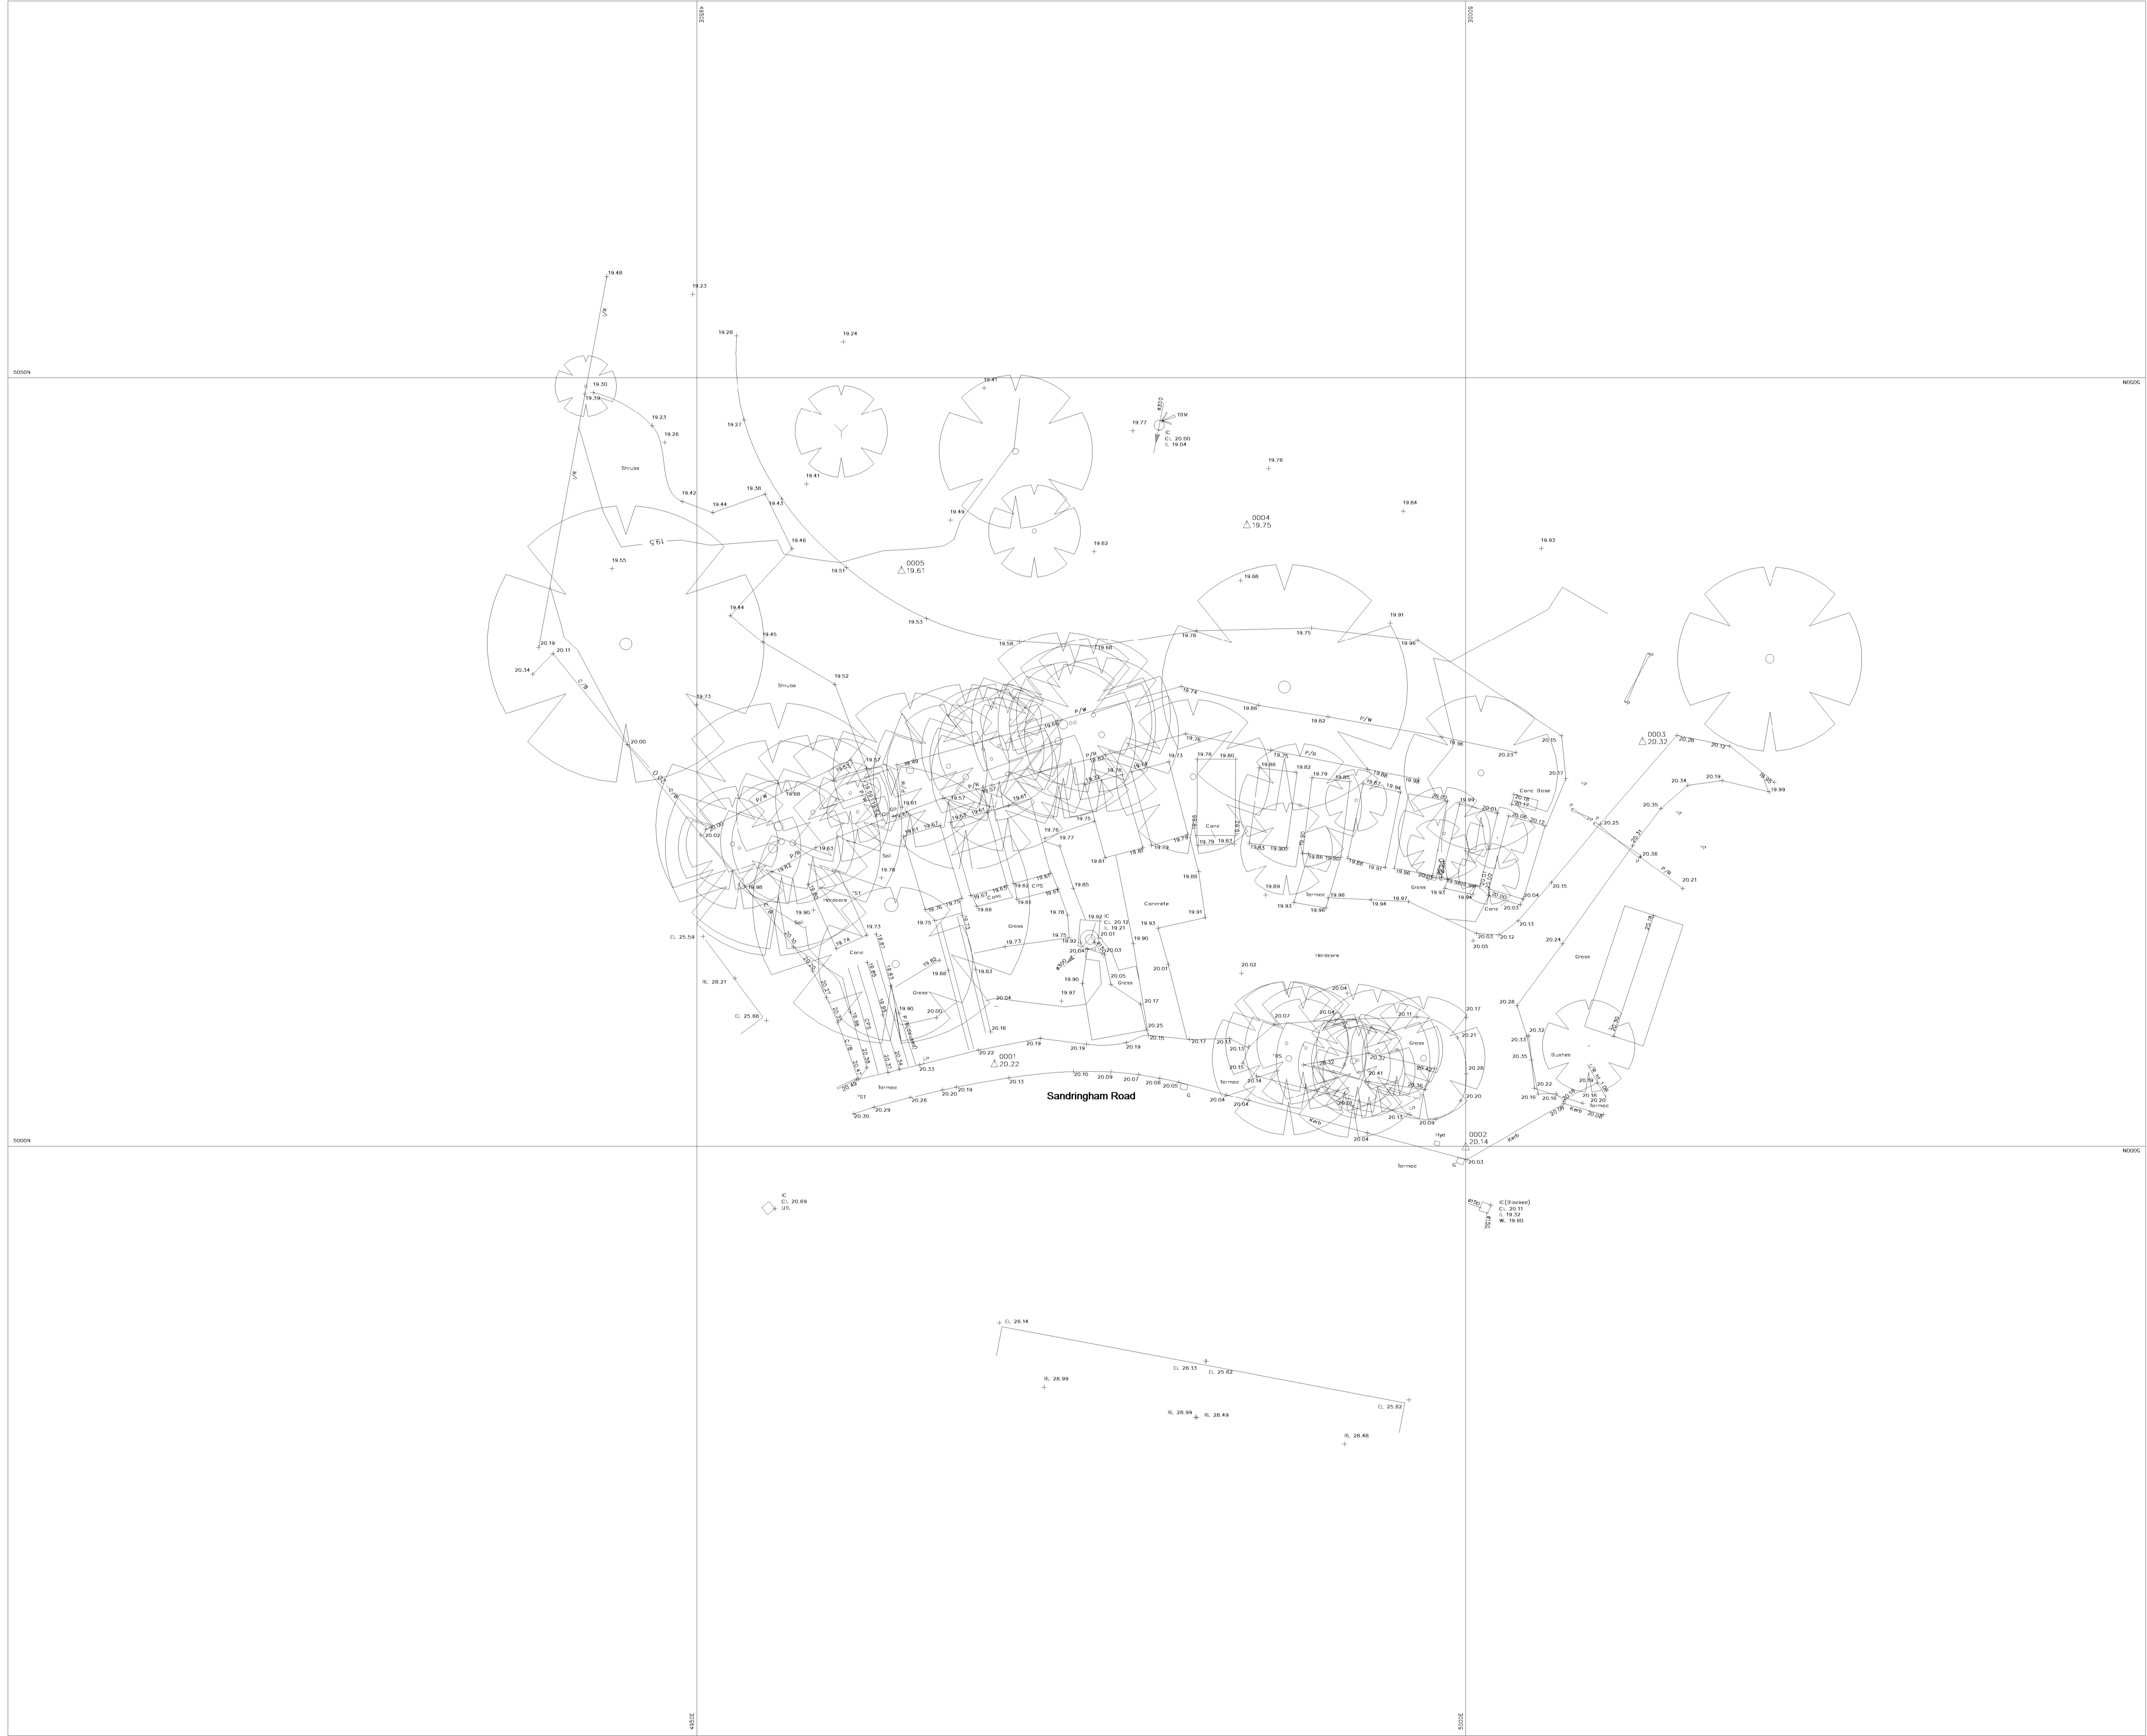
Site Layout Plan
1:500

All existing trees to be removed and replacements planted elsewhere as agreed with the Local Authority

- 1.2 It is understood that current development proposals comprise the demolition of existing residential garages and removal of trees to construct new two storey houses with associated gardens, access road and paved areas. A proposed development plan (Pozzoni Architects P2799-SK04, October 2011) is provided in Appendix 01.

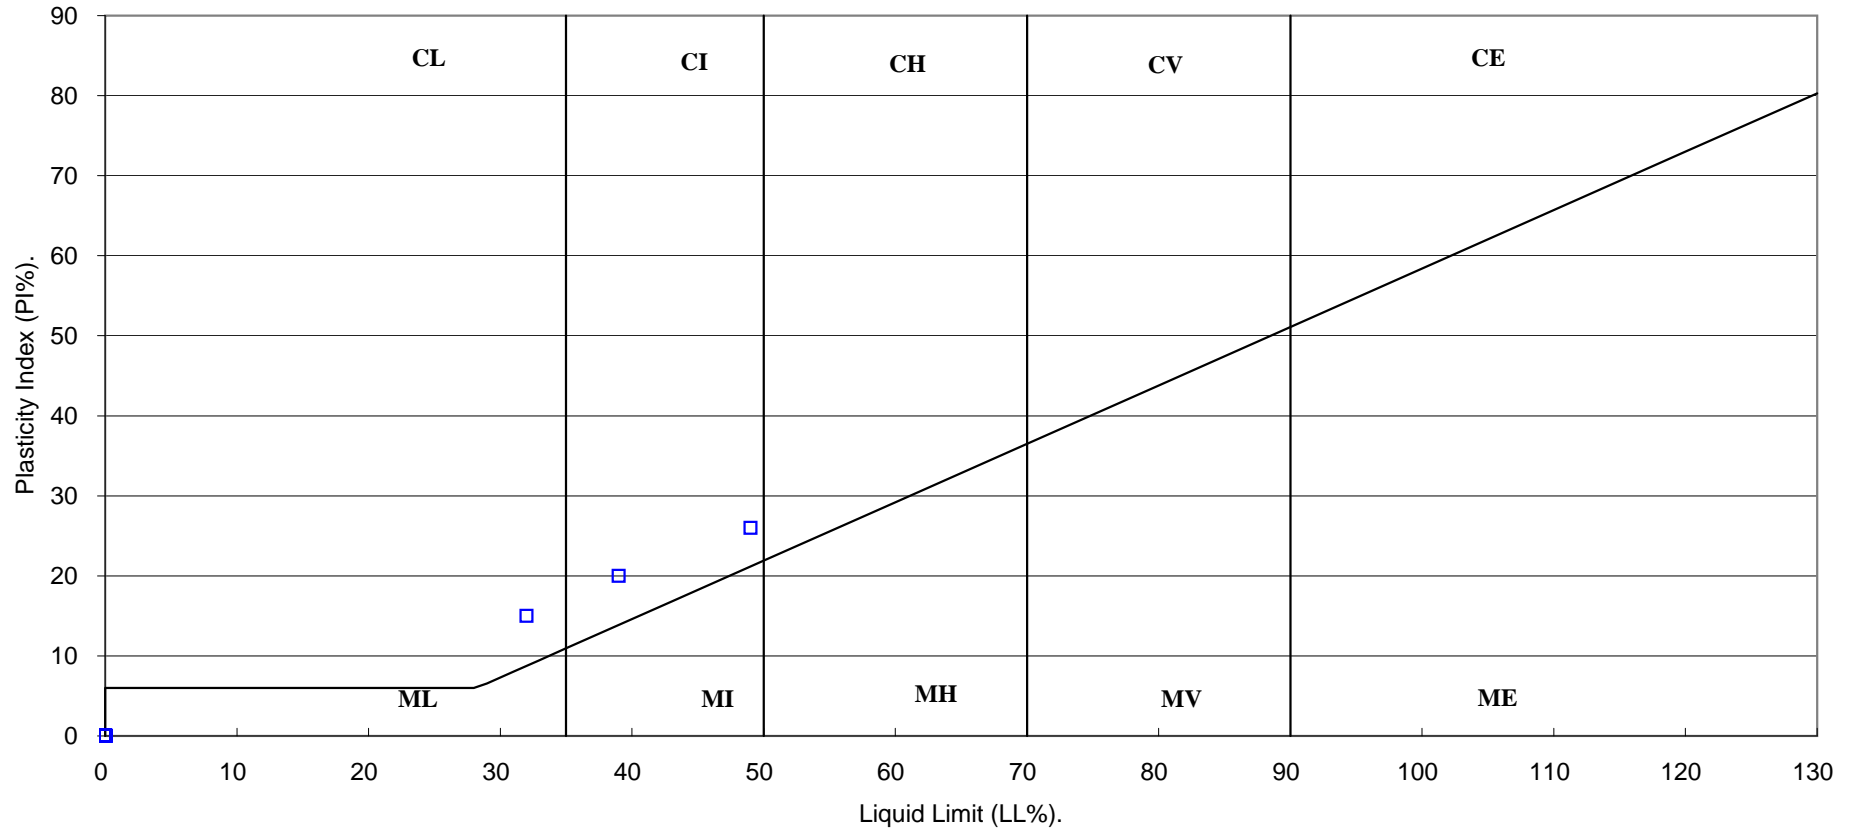
PLASTICITY CHART FOR CASAGRANDE CLASSIFICATION.

(B.S.5930 : 1999)

- 6.6 SPT 'N' values for the lower Glacial clay horizon ranged from 10 to 14 with an average of 12 indicating a firm consistency.
- 6.7 Laboratory Test results for the upper and lower clay strata indicate natural moisture contents of between 15 and 32% and generally decreasing with depth. Liquid limits of 32 to 49% with corresponding Plasticity Indices of 15 to 26% indicate the clay to be of low to intermediate plasticity and volume change potential.
